ROBERTSHAW CONTROLS COMPANY  
NEW STANTON DIVISION  
NEW STANTON, PENNSYLVANIA

GROUNDWATER INVESTIGATION  
INACTIVE PLANT DISCHARGE POND

PROJECT 79-204  
MARCH 1980

GAI CONSULTANTS, INC.  
570 BEATTY ROAD  
MONROEVILLE, PENNSYLVANIA 15146

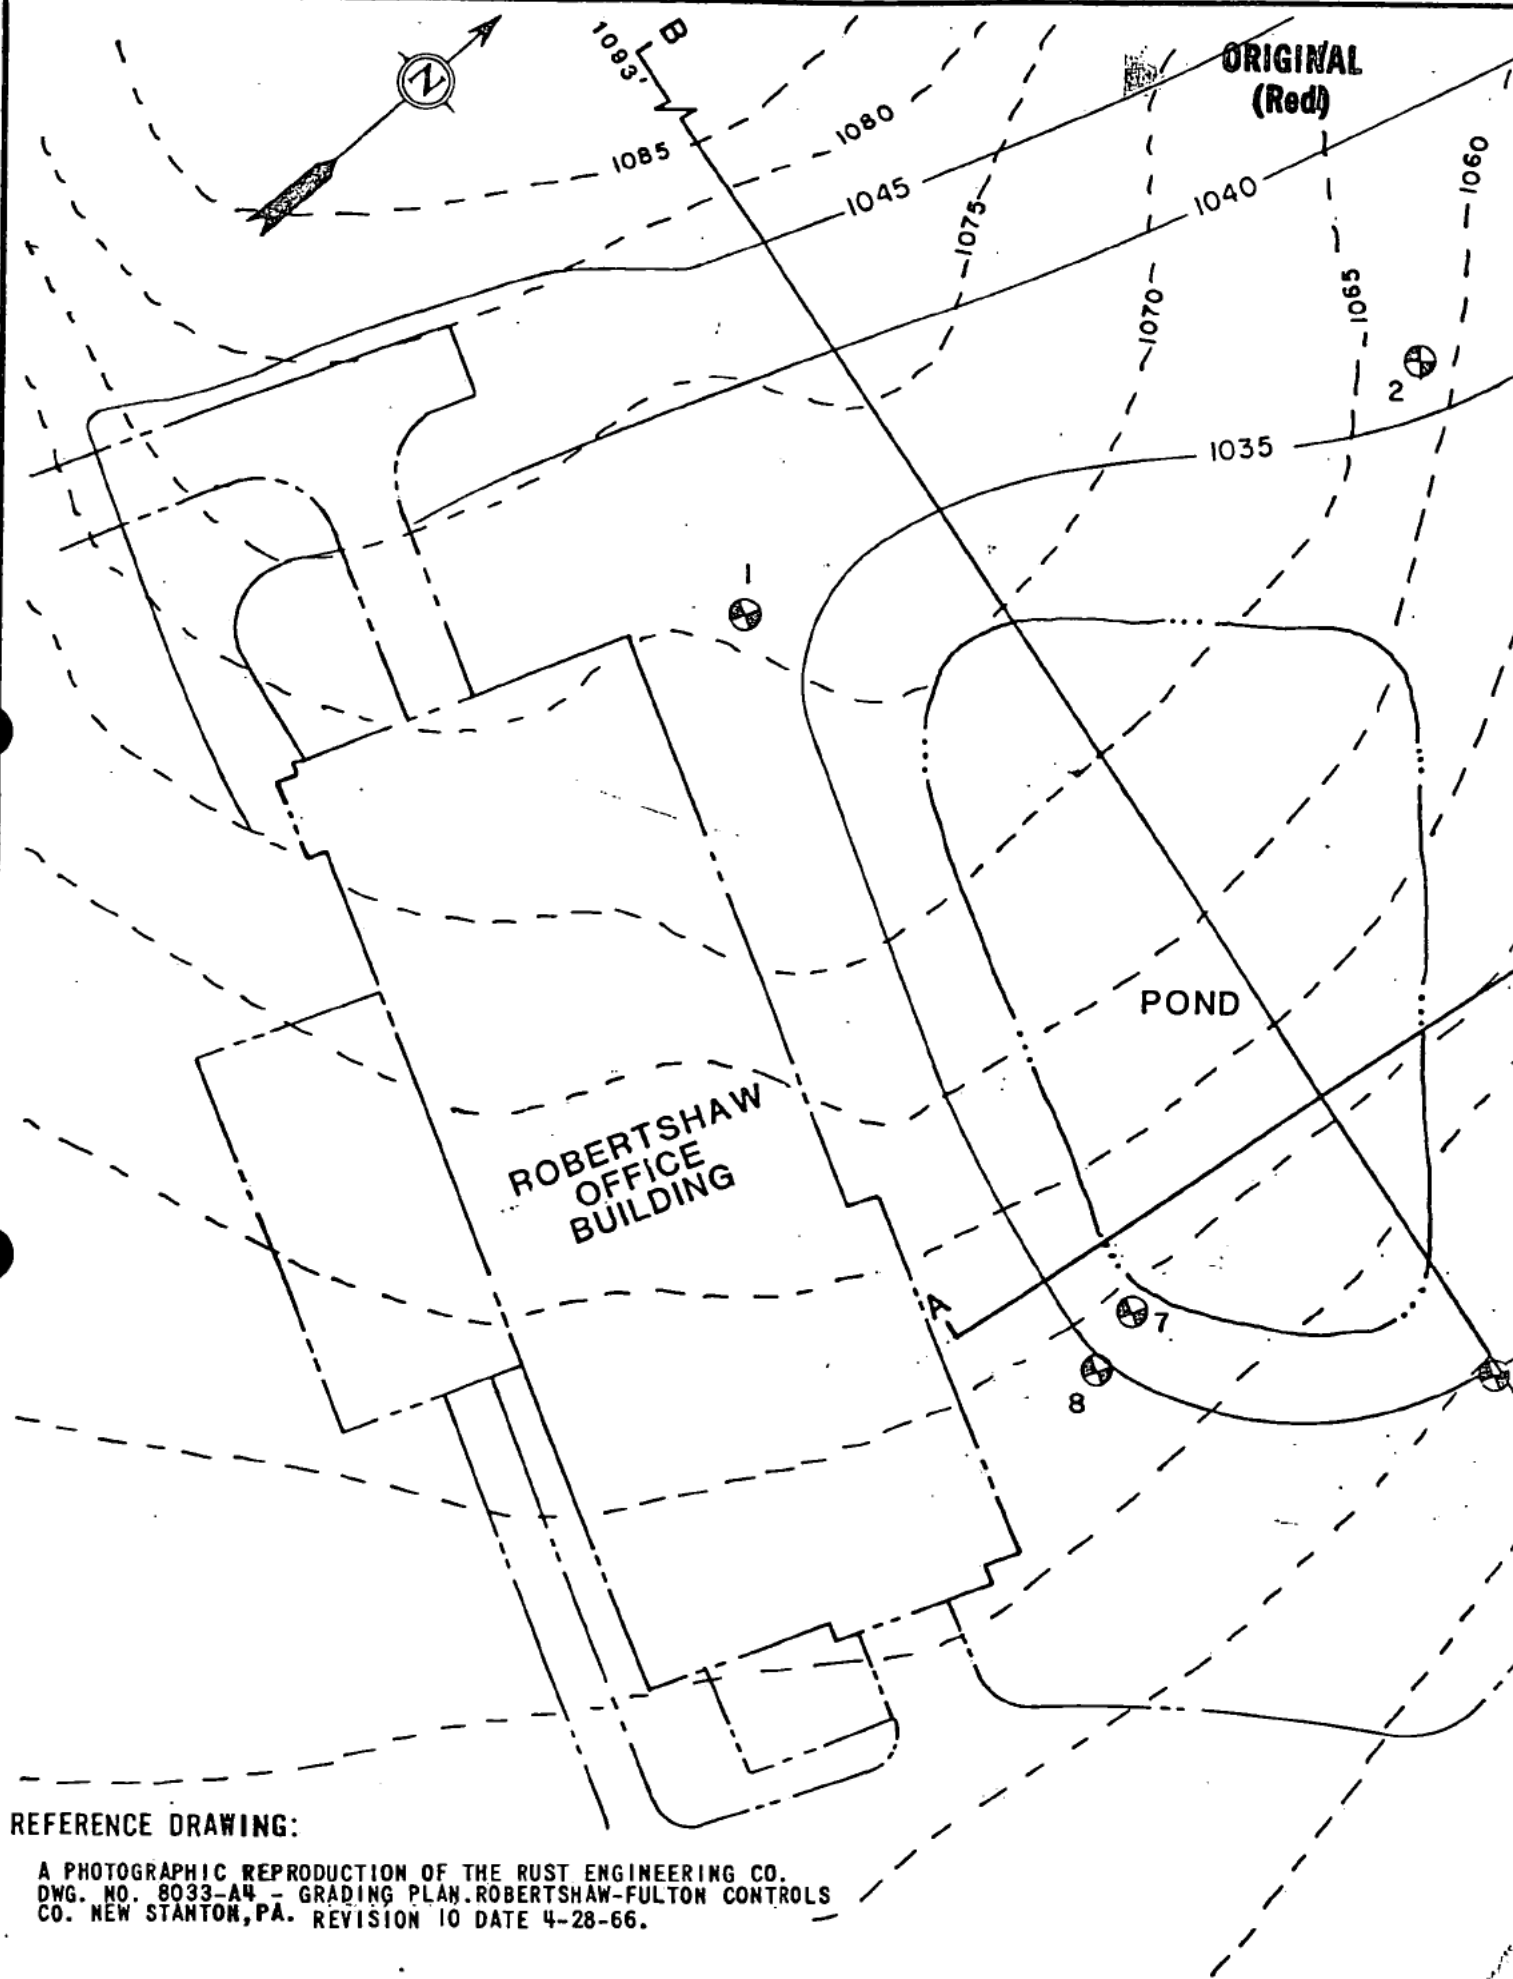
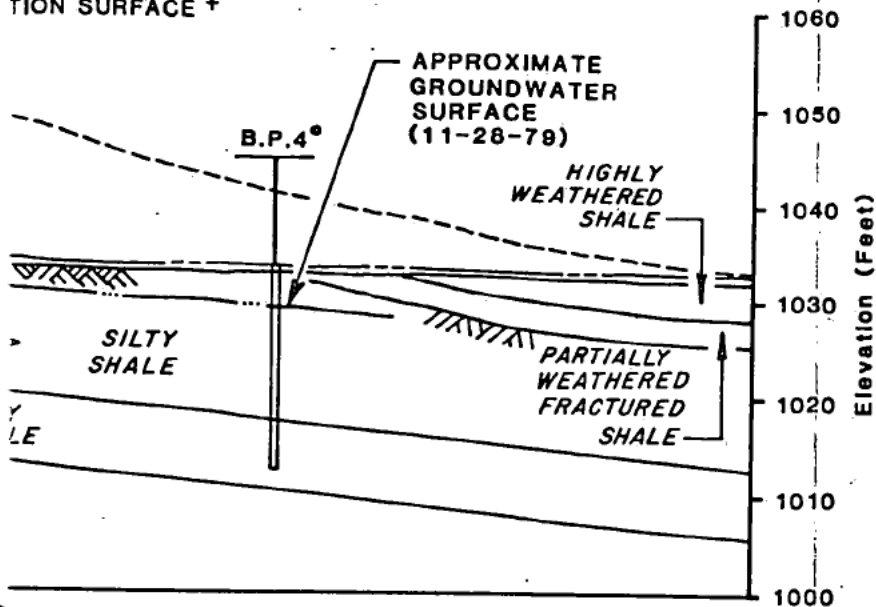
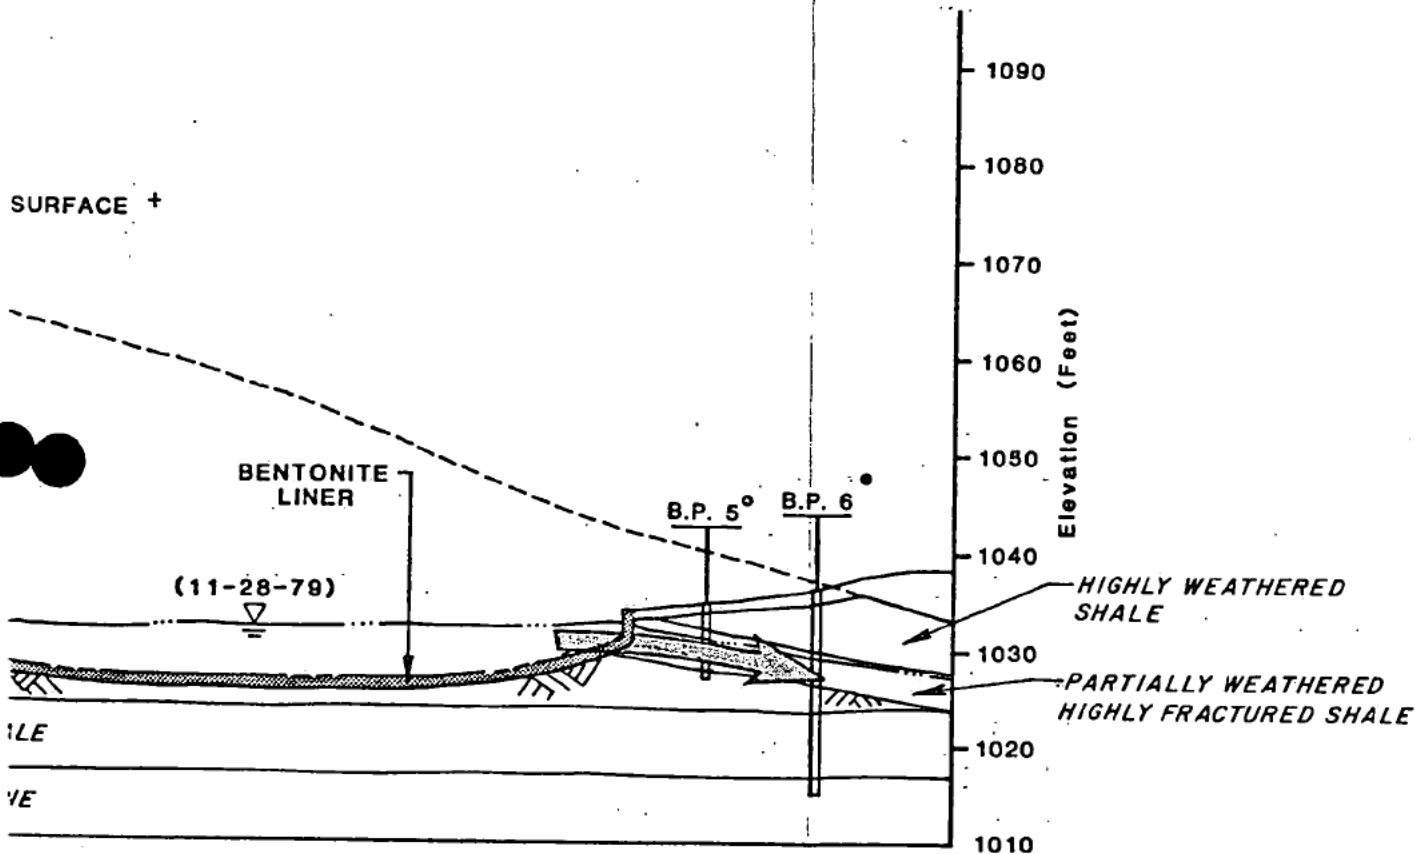
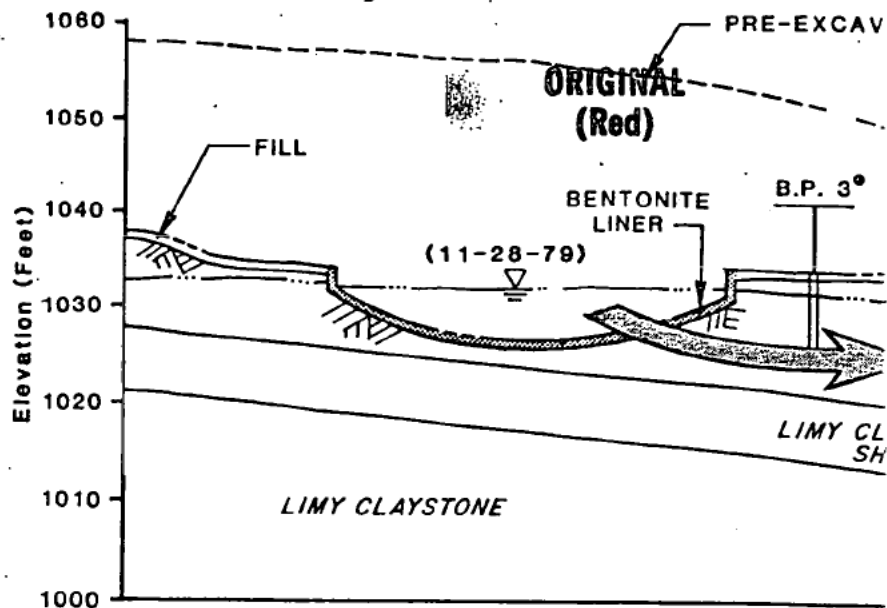
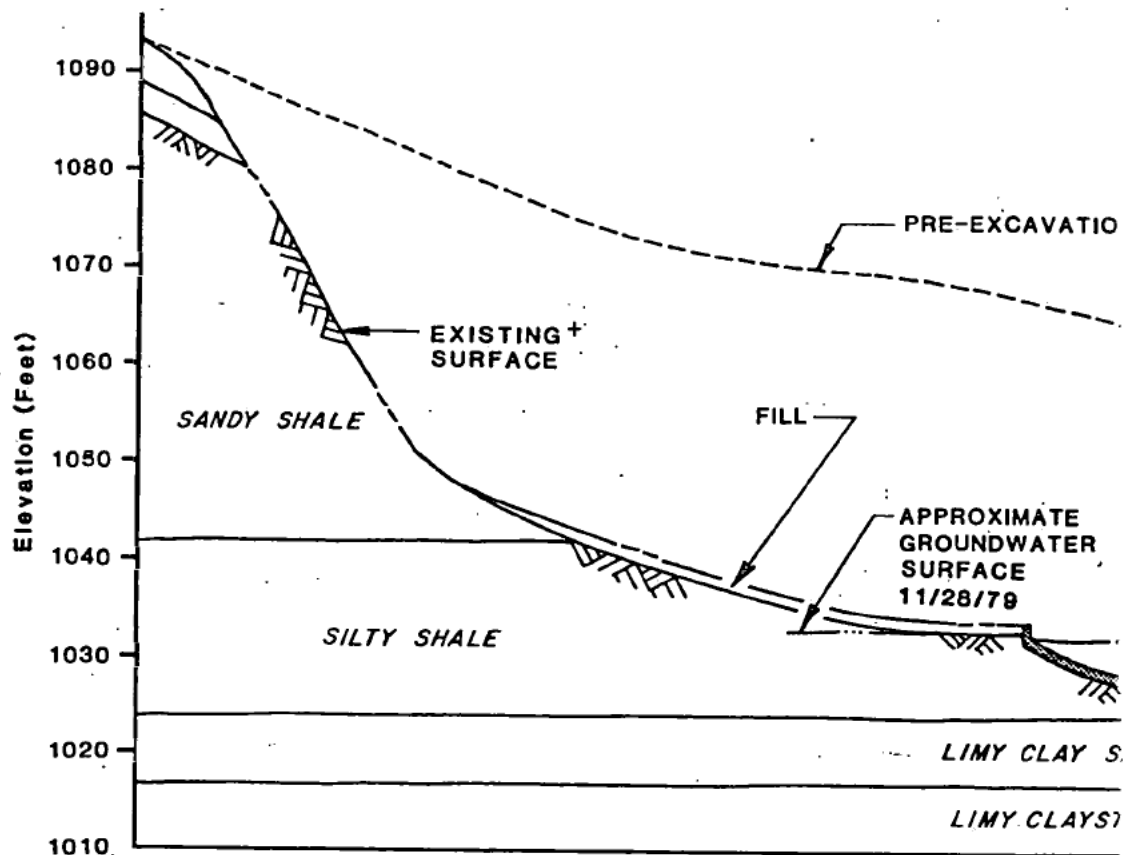
Figure 3 presents stratigraphic cross-sections drawn across the pond oriented along the strike and dip of the rock units. Cross-Section A-A' drawn down the dip of the inferred rock strata illustrates the potential for seepage to occur northeastwards down the dip of permeable rock strata. Previous boring logs prepared by Pennsylvania Drilling Company (9-16-58) describe a weathered rock mantle of from 8 to 14 feet thick on the preexcavation surface of this site. This unconsolidated mantle grades downwards from a highly weathered clayey silt surface soil to increasingly less weathered, yet highly fractured shale. High permeabilities and potential for subsurface seepage exists within the highly fractured shale which rests between impervious surface soil and intact bedrock. Remnants of this original

weathered mantle remain along the eastern end of the pond as described in Boring Logs 5 and 6. Since the preexcavation surface originally sloped towards the east-northeast (Figure 2), it can be anticipated that the weathered mantle which formed parallel to that surface, likewise dips in that direction beneath the existing graded surface (Figure 3). Thus, any seepage occurring along the eastern edge of the pond would tend to flow readily downslope along the fractured shale zone as indicated in cross-section B-B' on Figure 3.

CROSS SECTIONS ORIENTED WITH THE STRIKE  
AND DIP OF THE UNDERLYING ROCK STRATA

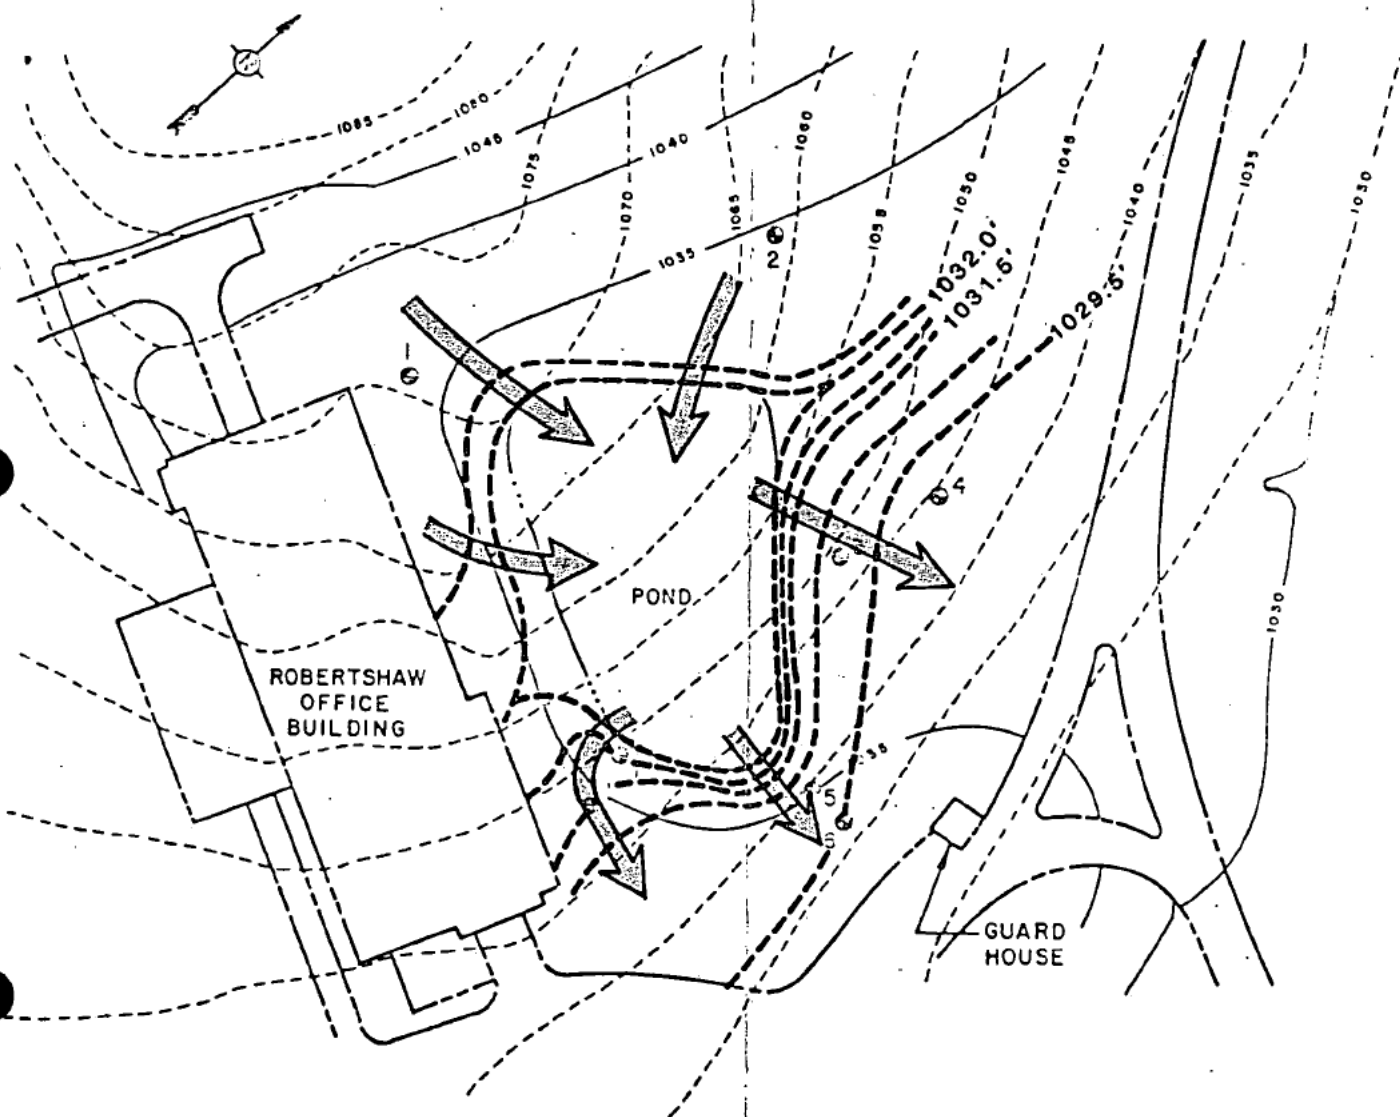
achieved, flowlines impinging on the pond liner system would be diverted around the pond as depicted in Figure 4c. If, on the other hand, there existed complete hydraulic continuity between the groundwater and water in the pond, then groundwater recharge of the pond would be expected along the western portion of the pond where groundwater elevations rise above the surface elevation of the pond. Concurrently discharge would occur along the eastern margin towards lower groundwater elevations on the downslope side of the pond as presented in Figure 4d. Noticeably, groundwater depths on the downslope discharge end of the pond tend to rise upwards towards the pond, intersecting with the surface elevation of the pond (Figure 3). This seems to suggest a degree of hydraulic continuity between these waters. If so two situations could exist. Either the structural integrity of the pond liner has been interrupted allowing direct flow through the pond liner or other groundwater conditions may exist. These include imperceptible fluctuations of the groundwater level which permit sufficient time for the pond waters to equilibrate with surrounding groundwater conditions, or the mere chance occurrence of equivalent groundwater levels. Verification of the degree of continuity could be obtained through an extended well monitoring program where fluctuations in the groundwater level are compared with fluctuations and response of water within the pond.

Figure 4d – Shallow Groundwater Flow Pattern  
Assuming Hydraulic Continuity with  
Pond

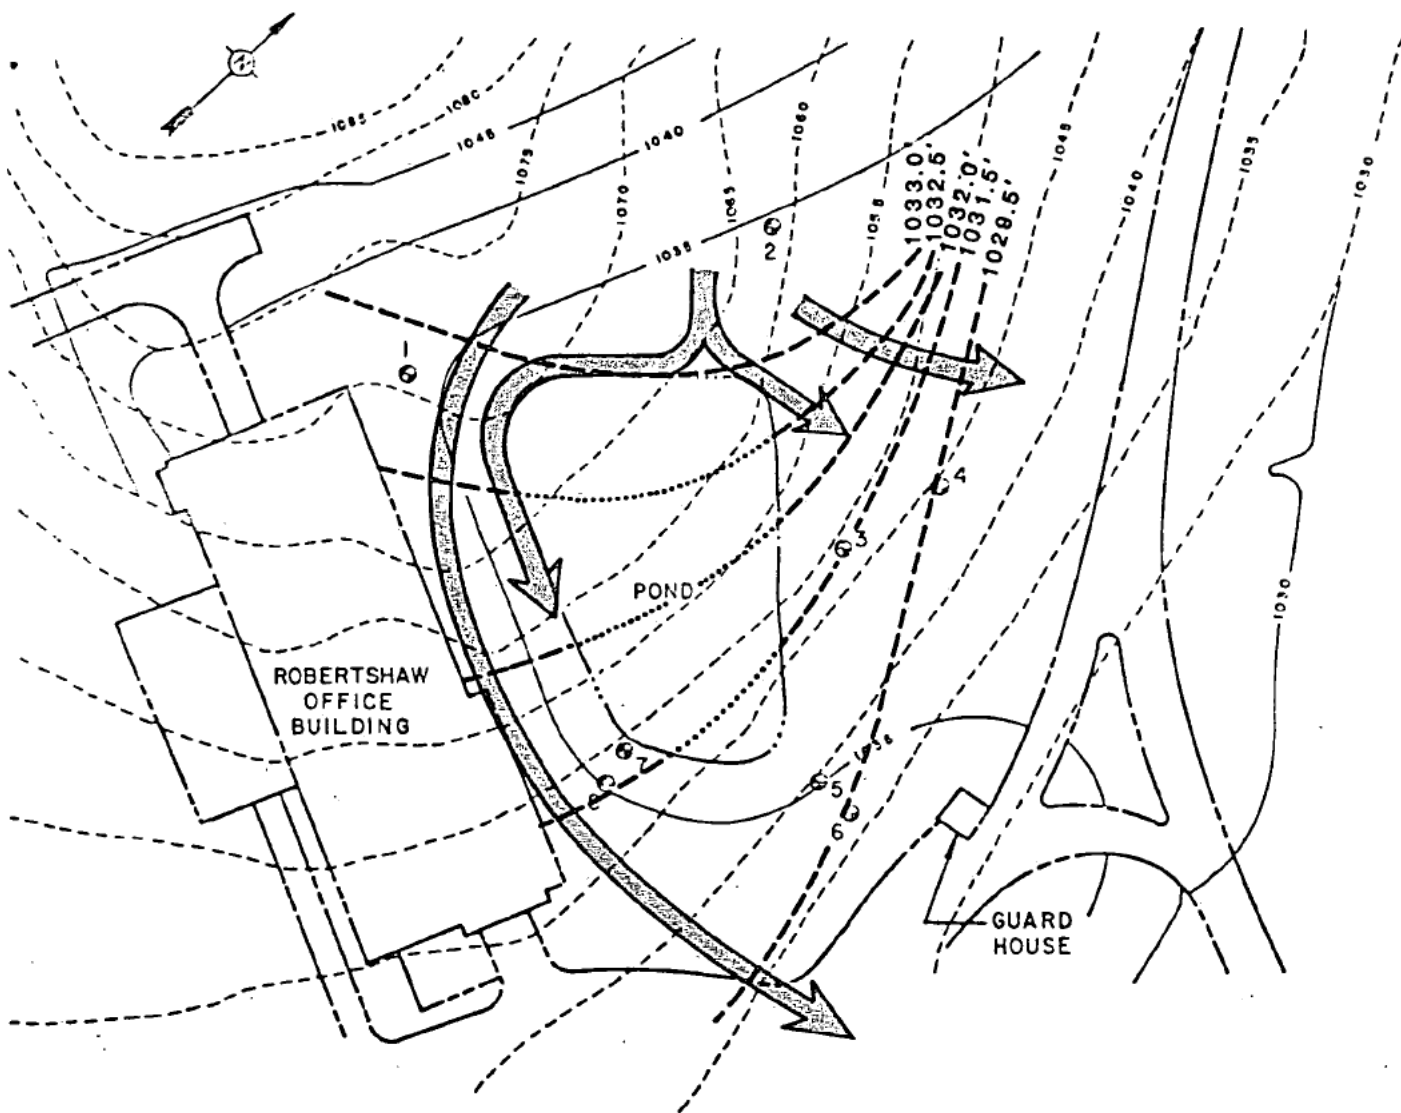
More detailed interpretations of the groundwater flow path around the pond can be made based on assumptions of the extent to which continuity exists between water in the pond and the surrounding groundwaters. If complete isolation of the pond water were

Figure 4c - Shallow Groundwater Flow Pattern  
Assuming No Hydraulic Continuity  
with Pond
